KWA Engineers, LLC
Structural Engineering Consultants

RE: Sutton Place Condominium – Slab and Seawall Erosion
1701 Castle Rock Road
Tampa FL 34612
KWA Opportunity #19RT-0275

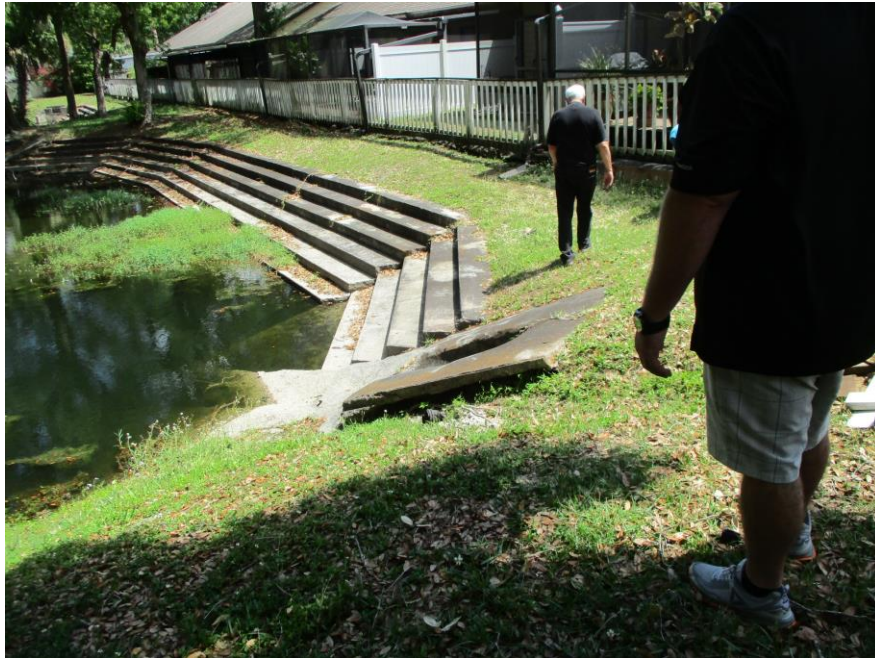
Overview of Sewall and Fence at North Elevation of Building

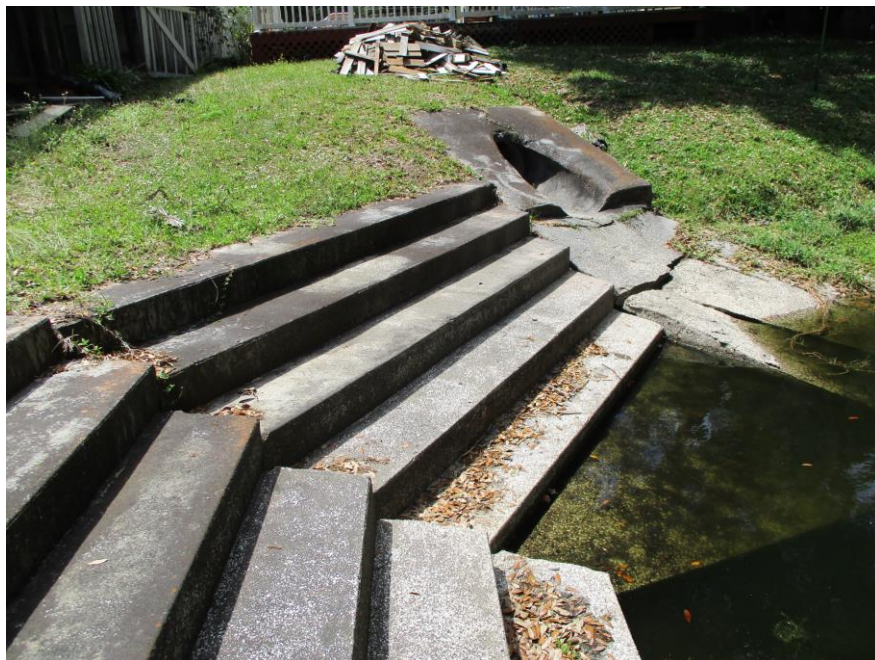
- 2) In general the seawall appears in relatively good condition. There were minimal signs of concrete spalling and cracking.
- 3) KWA noted that the wall section at the west end of the pond has settled due to undermining of supporting soil. KWA measured an approximately 16" deep void under the wall. It appears that the erosion may have been caused by a nearby drainage outlet pipe.

Based on observations, it is KWA's professional opinion that the erosion and settlement at the west end of seawall is due to water outflow from the adjacent drainage pipe. The cracking and settled apron slabs at the drainage pipes can also be contributed to water outflow over time. It is KWA professional opinion that the erosion at the patios and the fence footing can be contributed to an improperly designed footing/retaining wall. The wall was not constructed in a manner to properly hold back the existing soil.

Settled Wall Section at West End

- 1) The settled western section of seawall near the drainage pipe should be raised via chemical grout injection. The grout injection will fill in existing voids under the wall section and should raise the section to near pre-settlement conditions. The seawall directly east of the settled section should also be injected to ensure all voids are filled. Following injection any remaining gaps between the wall sections should be filled with a commercial grade repair mortar

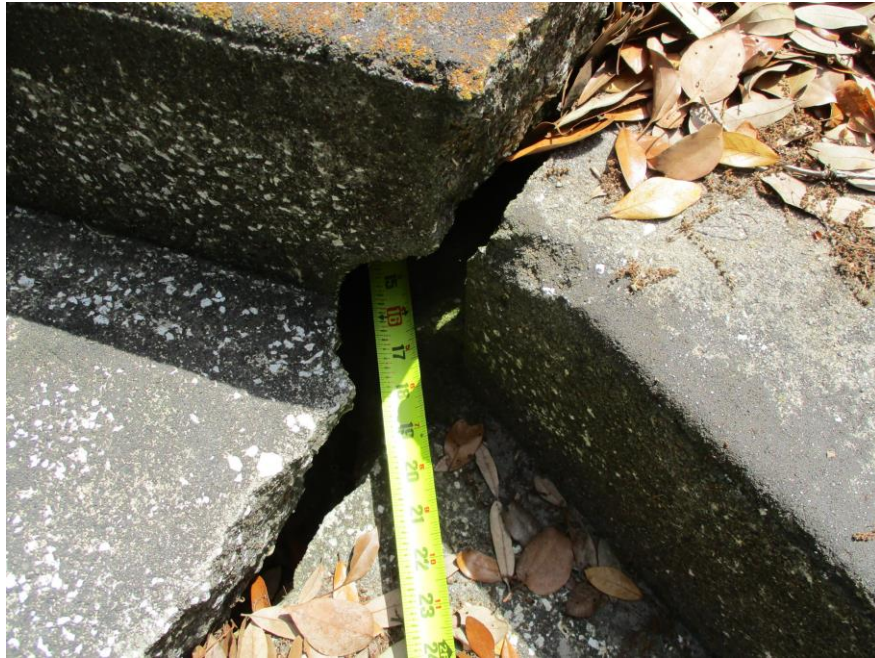
Void under Settled Section of Wall

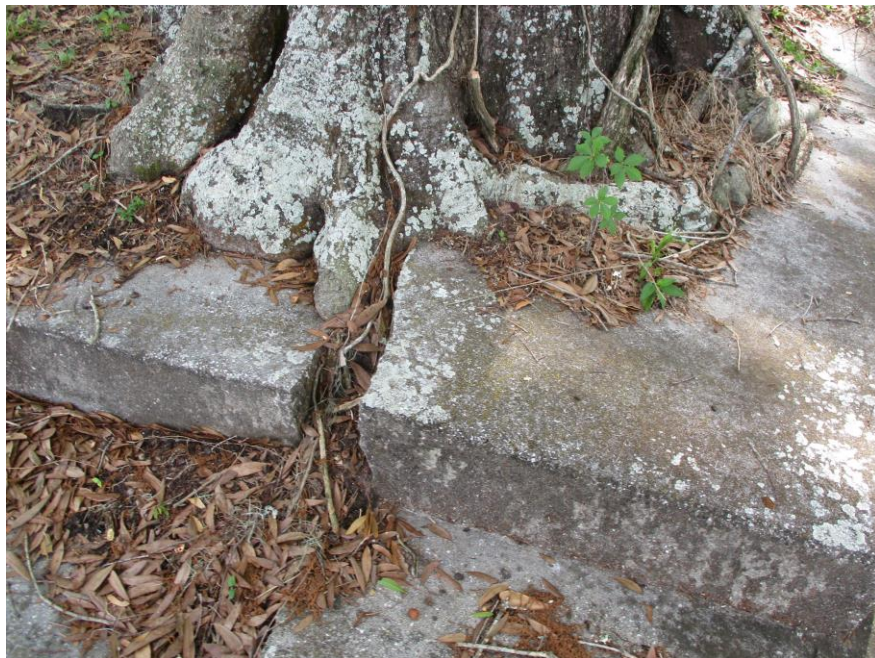
- 5) KWA also noted a large tree growing directly between two sections of the wall. The tree roots appear to be causing the wall to be moved towards the pond

Tree Growing next to Seawall causing Damage

- 3) Due to it's proximately to the existing seawalls and resultant damage caused by it, the existing tree should be removed. Prior to removal the Board should check whether any special permits are required to remove the tree. The Association may also need to hire an Arborist to inspect the tree to identify its specie.

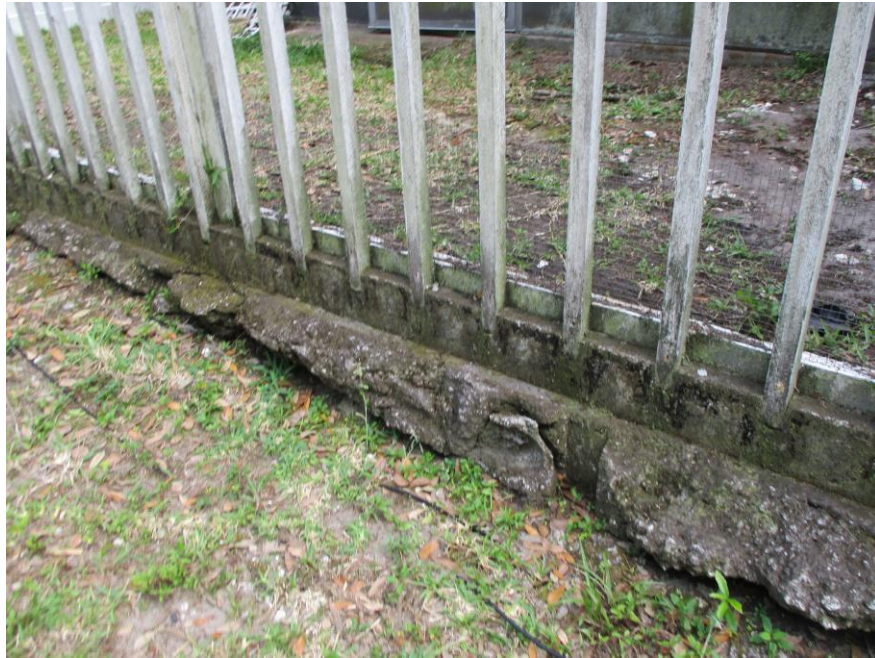
- 1) At the north elevation of the building, it appears that some unit owners over time have added patios. The patios consist of a concrete slab on grades which extent from the exterior wall of the units out to a wood fence that runs the entire length of the building. The fence is support by a small continuous cast-in-place concrete footing. Unit owners have also added concrete pavers at several locations to make patios.
- 2) KWA noted multiple areas which the soil has eroded from under the patio slabs and fence foundation resulting in unsupported slabs and cracking. It appears that the fence footing may have been added to control erosion. However, it was not deep enough to properly hold back the exiting soil

Existing Fencing supported by Concrete Footing

- 4) The pond should be cleaned to remove any overgrowth and debris. If left unaddressed, over time the overgrowth may damage the existing seawall.
- 5) To restore and the support of the existing patios, KWA recommends that the existing fence and its foundation be removed and replaced with a new code compliant concrete footing and small retaining wall. The new wall should extend the entire length of the building. Following proper curing of the new retaining wall, KWA recommends that the voids under the existing patios be filled via chemical grout injection. If desired, after repairs are completed a new wood or aluminum picket railing can be installed on top of the retaining wall in order maintain its current appearance and separate the patios from the pond area

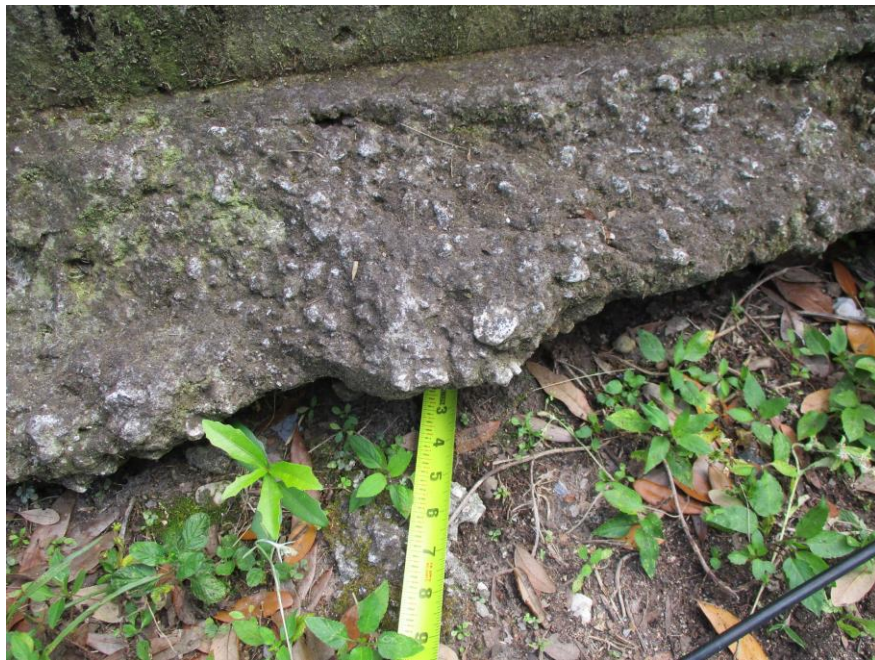
Voids under Existing Fence Footing

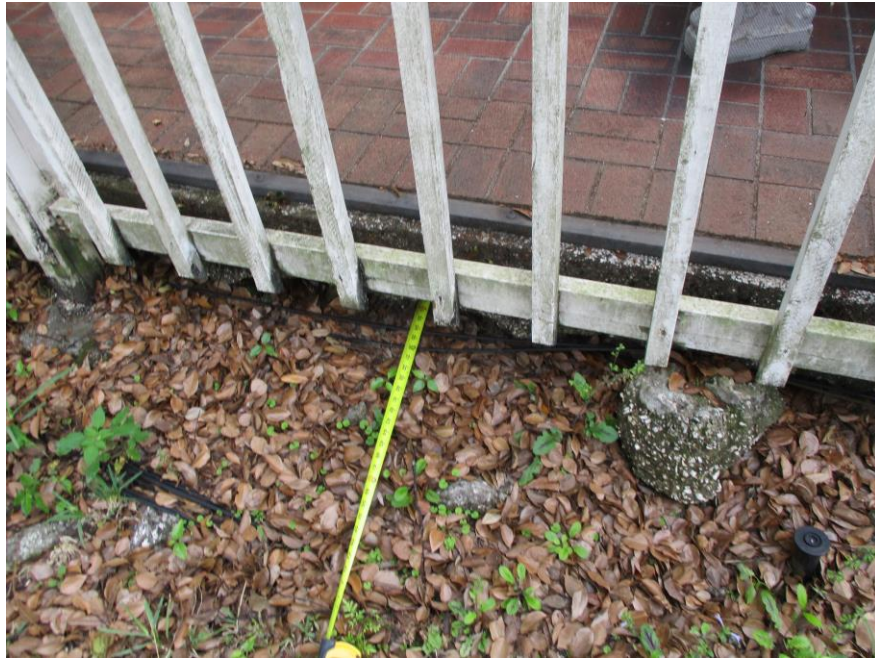
Void under Existing Patio Slab

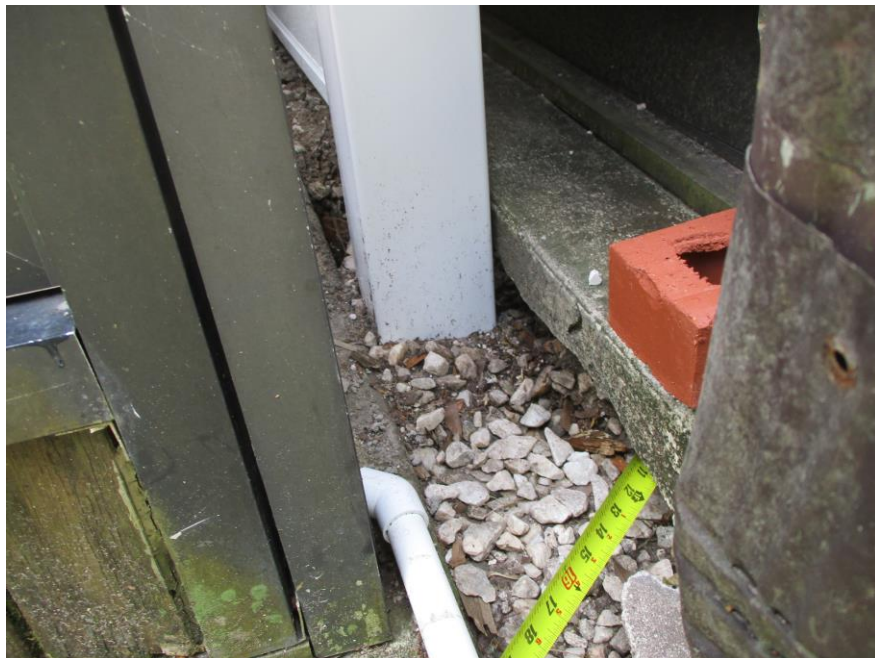
Void under Existing Patio Slab
